ILLUSTRATIVE SAMPLE PACK

Assessment report

DAILY WATER BALANCE

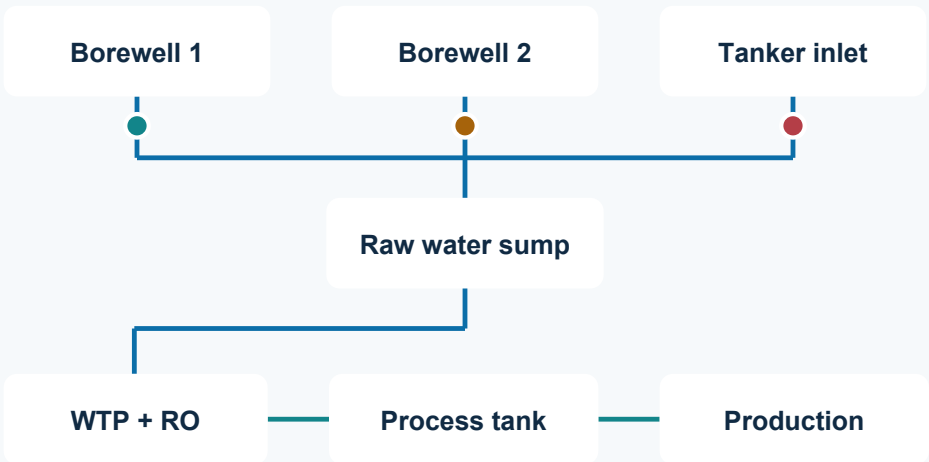
WaterOS diagram

- **Working** — Borewell 1 readings match pump hours.
- **Faulty** — The Borewell 2 meter has stopped registering flow.
- **Gap** — The tanker inlet has no meter.

Replace the faulty borewell meter and meter the tanker inlet. Reconcile deliveries against the site water balance.

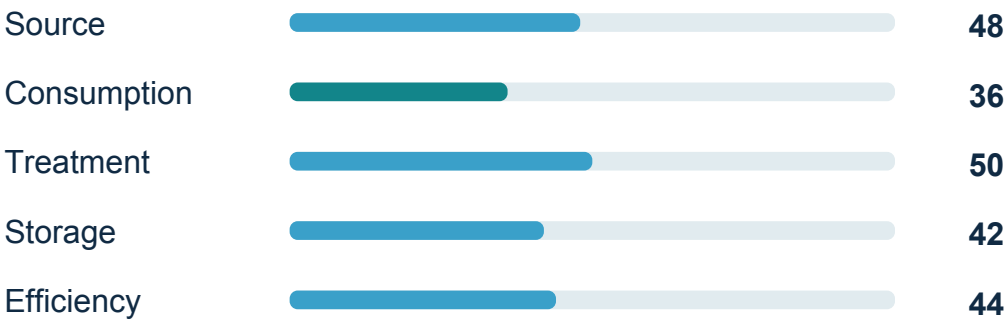
WIAF scorecard

Five pillars show where the site has reliable water data and where an intervention can improve its score.

44 / 100

Level 2 / Aware

Meter the three production lines separately and add a meter to the boiler feed. Check shutdown flow after repairing the suspected Line 3 leak.
